***If you suspect that your TMC isolation system is leaking (most often evidenced by going through air/nitrogen tanks too quickly), this guide will help you to find and fix the problem. Illustrated photos are of a CleanBench Lab Table, but items shown are common for all TMC isolation systems.***

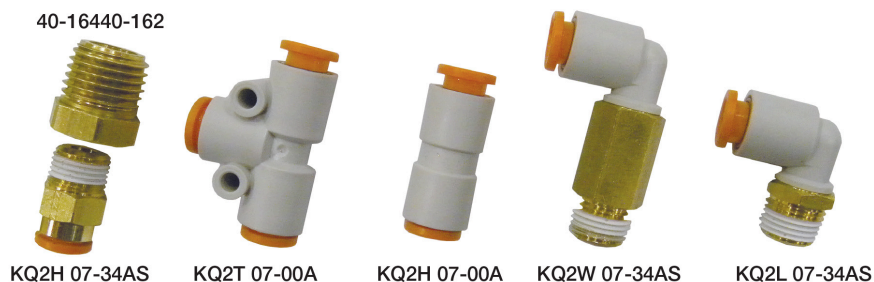
**FIGURE 1**

The fittings you'll find on your system are shown in Figure 1 below:

Male Connector, Part Number: KQ2H 07-34AS

This fitting has a male “1/8 NPT” (National Pipe Thread) on one end and a “press-lock” connection (red or orange plastic) for 1/4” OD flexible tubing on the other end. It is provided as one of two fittings supplied to connect to your air source and at the INPUT port of the supplied air filter & the three height control valves.

1/4x1/8 Brass Reducing Bushing, Part Number: 40-16440-162

This fitting is supplied in case the 1/8 NPT thread on the Male Connector is too small for the output fitting of your air source. It has a female 1/8 NPT thread on one end and a male 1/4 NPT on the other end.

Male Elbow, Part Number: KQ2L 07-34AS

Male 1/8 NPT on one end, and the press-lock on the other. This is found at the OUTPUT ports of the air filter and the three height control valves.

Union Tee, Part Number: KQ2T 07-00A

There are three “T’s” in a 4 isolator system, two coming from the output side of the filter to distribute the air to the input ports of the three height control valves, and one more to distribute the air from

the output port of the “Master” valve (one of the three valves will be controlling two legs) to its own leg and to its “Slave” leg. All three ends of the Tee are press-lock.

Connector (Straight Union), Part Number: KQ2H 07-00A

This fitting is a splice for ¼” OD flexible tubing. It is used to connect the short length of special tubing that goes into each leg (at TMC, we call this short length of tubing a “pigtail”) to the tubing coming from the output port of its controlling height control valve. Press-lock fittings at each end.

Extended Male Elbow, Part Number: KQ2W 07-34AS

This fitting is the input at each leg, the tubing connecting to it comes from the output side of its controlling height control valve. It is “extended” to allow it to reach through the outer post of the leg to the isolation module inside. It has a male 1/8 NPT thread where it goes into the module and a press-lock at the outer end to accept the tubing.

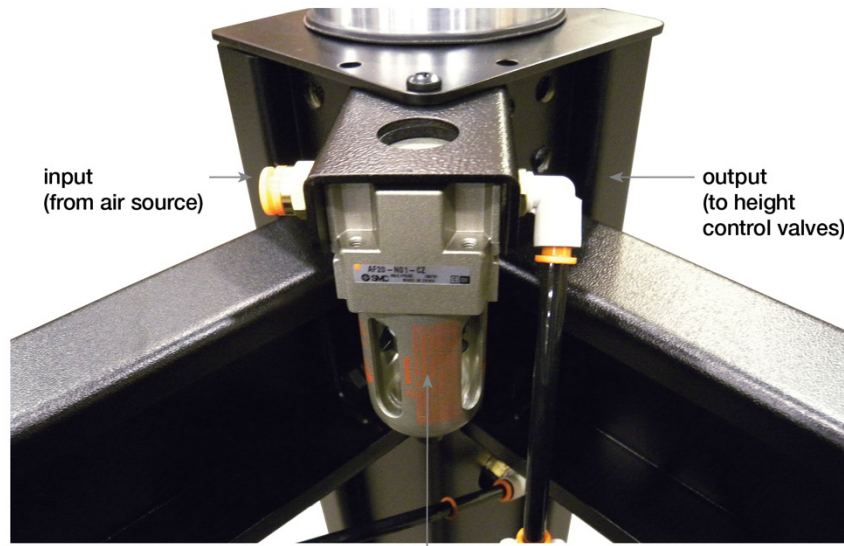
**FIGURE 2**

The Air Filter you'll find on your system is shown in Figure 2:

86-18770-01

Using the leak detection fluid described above, check the joint where the clear collection bowl joins the main body of the filter, and around the release valve at the bottom of the bowl.

If either area is leaking, there is no fix, and you will have to replace the filter.  
Call (800-542-9725) or email ([service@techmfg.com](mailto:service@techmfg.com)) for prices.

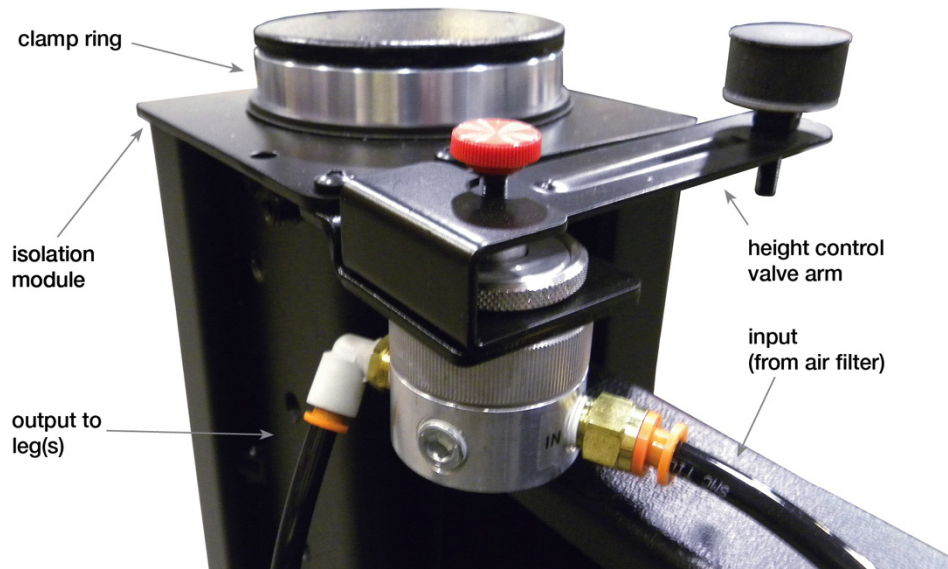
**FIGURE 3**

The Height Control Valves you'll find on your system are shown in Figures 4 and 5):

Isolation Module on your system is shown in Figures 3, 6, & 7:

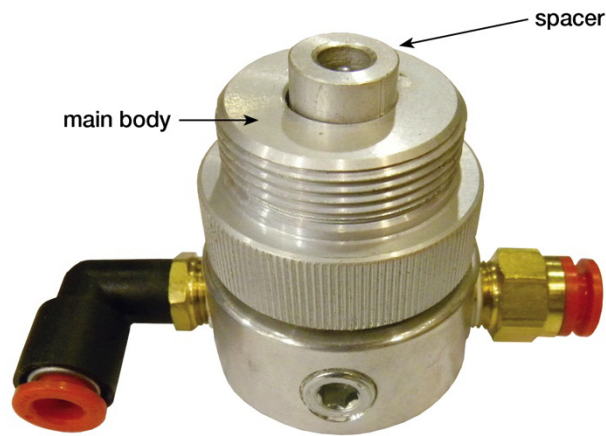
**FIGURE 5**

height control valve  
with externals removed  
for clarity

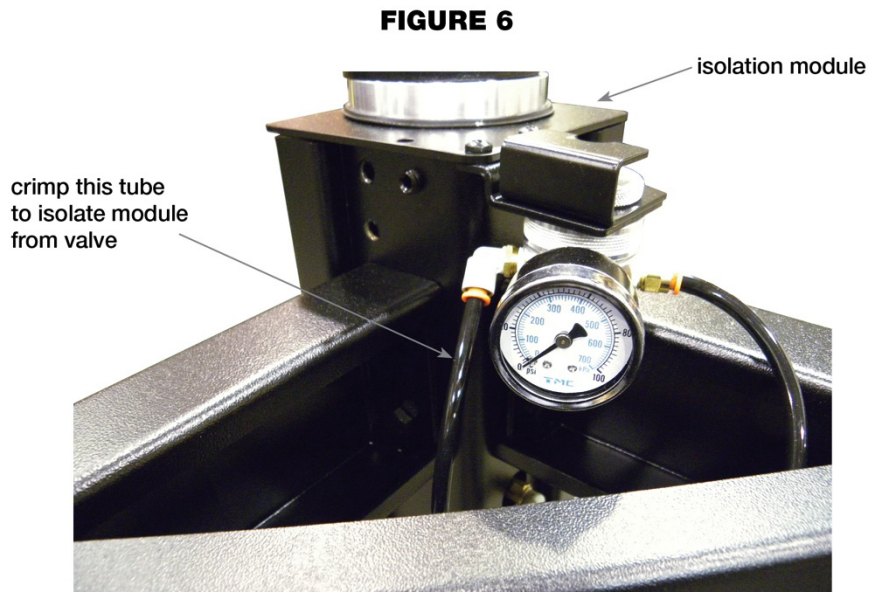
Isolation Module, Part Number: 64-35008-01

Pressurize the system and make sure the table is floating correctly. Go to the leg that deflated the soonest. You'll notice a tube going from the output port of the valve ("Male Elbow", see Figure 6) to the input of the leg itself ("Extended Male Elbow", see above). Find a point in that tube where you can bend it enough to crimp it:

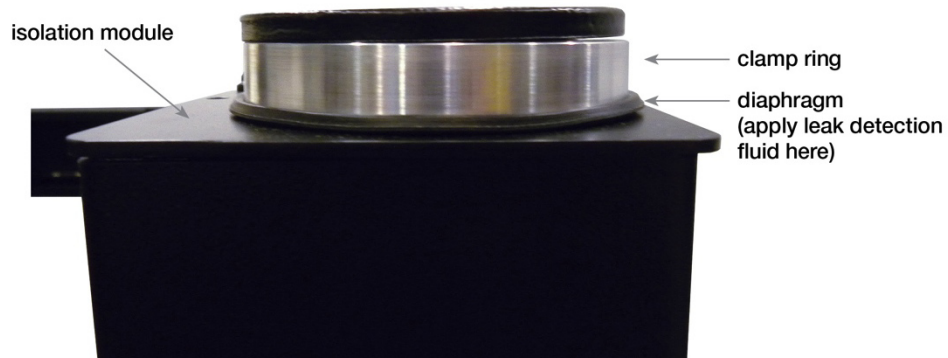
**FIGURE 7**

If this leg is still the first one to deflate, then the problem is in the module. There is one more thing you can try. Un-crimp the tube and use the leak detection fluid you used on the fittings to coat the outside of the diaphragm where the clamp ring seals it against the module. See Figure 7.

If the fluid bubbles here, then you may still be able to fix the leak by tightening the Allen Head screws that attach the clamp ring to the module. They may have loosened slightly over time, and tightening them could fix the leak.

HINT: You will need to adjust the height control valve higher to get enough clearance to get at these screws. We recommend that before you do this, you adjust the supply pressure to no more than 10 psi above the pressure in the leg (the reading on the pressure gage).

If there is no leak here, or if tightening the screws does not seal the leak, then you will have to replace the module. You will have to get the top out of the way (because the module comes straight up to remove it), but once you do, the rest of the replacement process is straight-forward. Call (800-542-9725) or email ([service@techmfg.com](mailto:service@techmfg.com)) for prices.
